First published in *The Bulletin* Volume 43 Number 3 (1999)

# THE LOSS OF THE “ELLAN VANNIN”

by L.N.R.S. Member Ron Evans

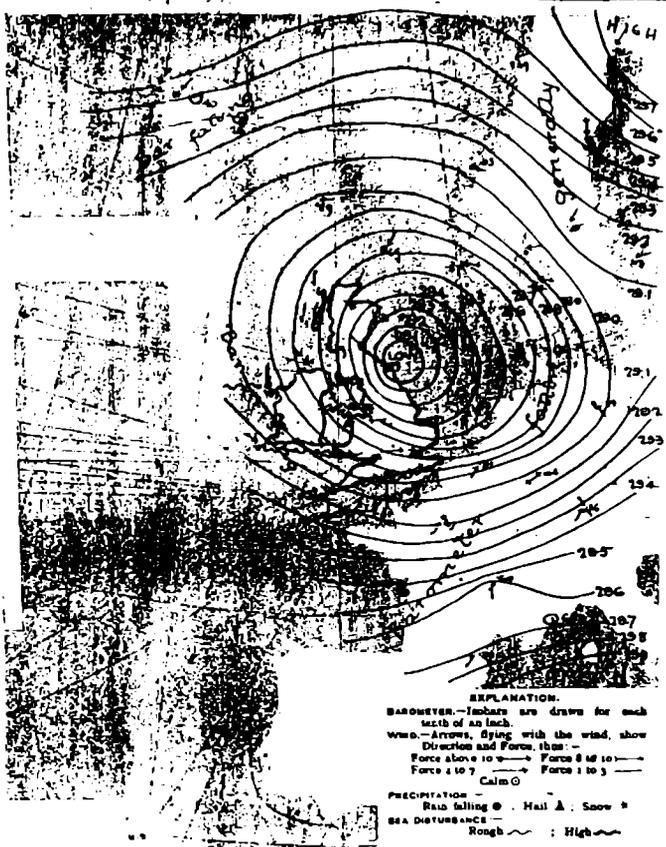
I. BAROMETER, WIND AND SEA AT 7 A.M. TO-DAY.

In the course of the past night an exceptionally deep cyclonic disturbance has crossed the country from the Atlantic to the North Sea, and the barometer is now at nearly 10 in at the north of the Iype, and below 10 in over the British Isles generally, the low continues North Germany and Eastern Norway. At the Cape the barometer stands about 30.5 in. The gradient is very steep all round

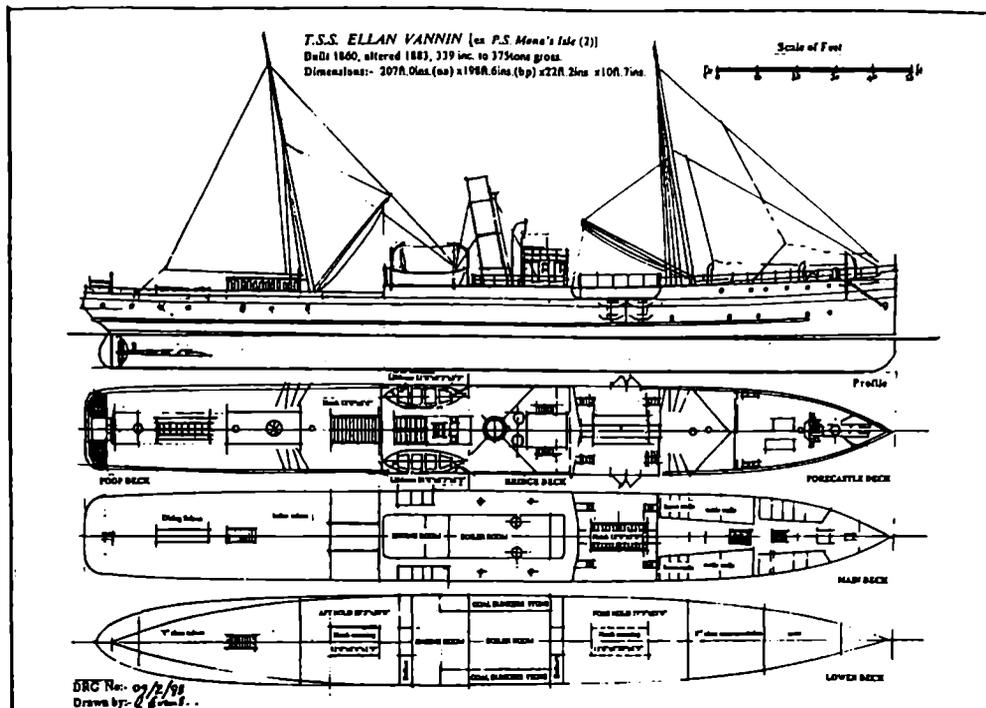
- 1] Oscillating engines were changed to vertical compound engines requiring repositioning.
- 2] Boiler dimensions and positions were changed resulting in changes to their CGs.

- 3] Forecastle and Bridge Decks were added to form a well deck.
- 4] Paddles and sponsons were removed reducing the overall deadweight by about 60 tons.

- 5] Beam overall sponsons reduced from 43ft 6ins (approx) to beam (moulded) 22ft 2ins.
- 6] Twin screws instead of paddle wheels could have made the very narrow hull difficult to handle in very severe sea conditions especially if rudder dimensions were unaltered.

- 7] Beam to length ratio was 8.95 and beam to draught ratio was 2.535 compared with the **Fenella** (1) of 1881 of 7.69 and 2.30 respectively, indicating that the **Ellan Vannin** had a very slender hull of shallow draught compared with her contemporaries.

- 8] Hatches fore (15' x 7') and aft (12' x 6'6") were twice the size of comparable vessels.
- 9] Deck structure over aft companionway to the saloon. Referred to in the Inquiry, but taken in conjunction with the very large after-hatch and the large skylight, a feature of the early paddle steamers, these could have provided many large openings for the inflow of water.

- 11] It will be noted that the **Ellan Vannin** was trimmed with a deeper draught aft than forward, many photographs refer. The deeper draught aft could have made her more vulnerable to following seas; the steps down to the main deck below the new bridge deck could have made the engine and boiler room more liable to flooding from aft, by-passing bulkheads.

- 12] The **Ellan Vannin** had the minimum of four bulkheads recommended at that time positioned at each end of the cargo holds and between engine room / boiler room. The forward bulkhead would also have served the dual purpose of a collision bulkhead.
