First published in *The Bulletin* Volume 43 Number 3 (1999)

# THE LOSS OF THE “ELLAN VANNIN”

by L.N.R.S. Member Ron Evans

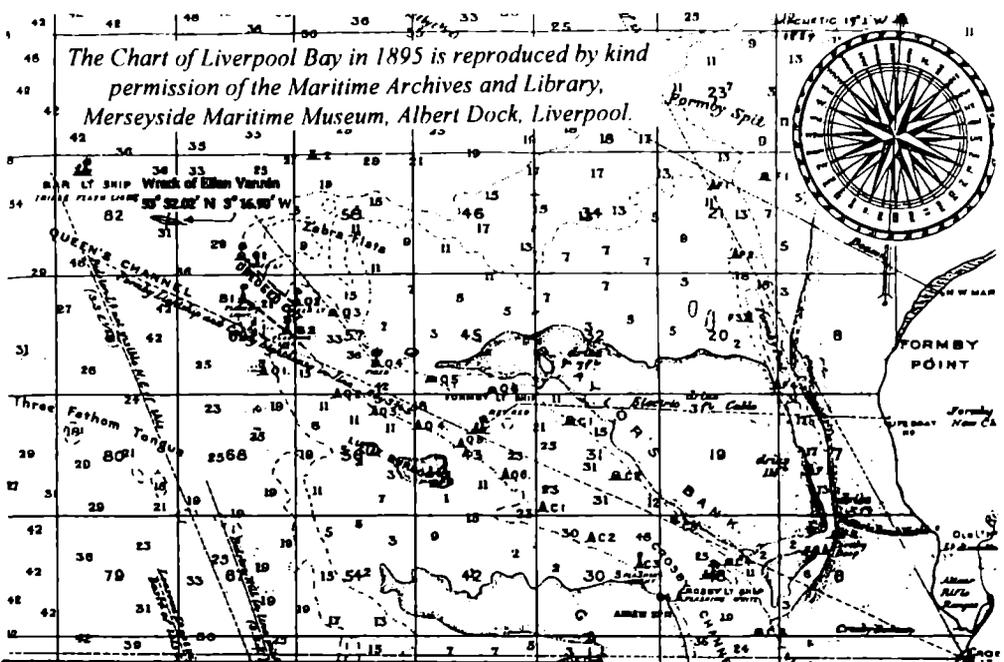
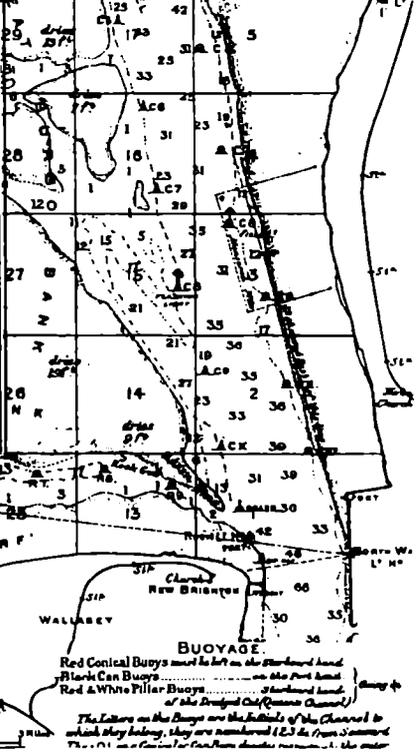
**LIVERPOOL BAY.**

The wreck of the **Ellan Vannin** was located on 4th December 1909, 1,170 yards from the Bar Lightship and 1,000 yards from the position of Q.1 Black Buoy on a direct line between them, and broadside on to the tide. The wreck was heading about West by South; the fore end was broken off about 35 feet from the stem and was separated from the after part by a space estimated at about 6 feet. The after portion was nearly upright; the forward portion had a list to port of from 15 to 20 degrees on the first examination. This list was increased to about 45 to 50 degrees on the 12th December when the last examination was made. The break, the whole way round from rail to rail was a straight one mainly in the line of the rivets, varying not more than 6 or 8 inches either way, except on the port side where the stringer waterway and sheer strake was attached to the forward part, and projected aft about 4 feet. The keel of the fore part at the fracture was bent up about 3 to 18 inches. The deck in the wake of the fracture was torn across except where the butts come; there the butts were torn but taking the deck bolts with the planks. Two divers reported an indentation of a part of the two plates below the sheer strake on the port side of the fracture, of about 18 inches in length in a vertical direction, the broken edges of the plates being bent inwards from 3 to 6 inches. One of the other divers did not notice any such indentation, and the fourth denied that it existed, but stated that some of the plates in the neighbourhood of the bilge were bent slightly inwards and upwards. The Court, however, does not attach much importance to the evidence on these points. The davits on the starboard lifeboat were stated to have been swung and guyed out. The boat was gone from the chocks. This boat was found the day after the wreck on the beach at New Brighton bottom up, cover on, and all her gear in. The davits of the port lifeboat were swung out but not guyed, the boat was gone, and no trace of her has been found. The divers found that the square house (which contained the saloon entrance and smoke room) on the after deck was completely washed away, only the whaling pieces on the deck being left to indicate where the house had been.

Here it may be mentioned that a theory was advanced that the **Ellan Vannin** fouled the Q.1 buoy. The buoy was reported by the master of the ss **Heroic** to have been in place when he passed it at about 6.am. It was missed from its position by those on board the Bar Lightship at 10.am. This buoy was recovered on the 4th December, but no marks were found on it, and the light was still burning. Therefore the Court is

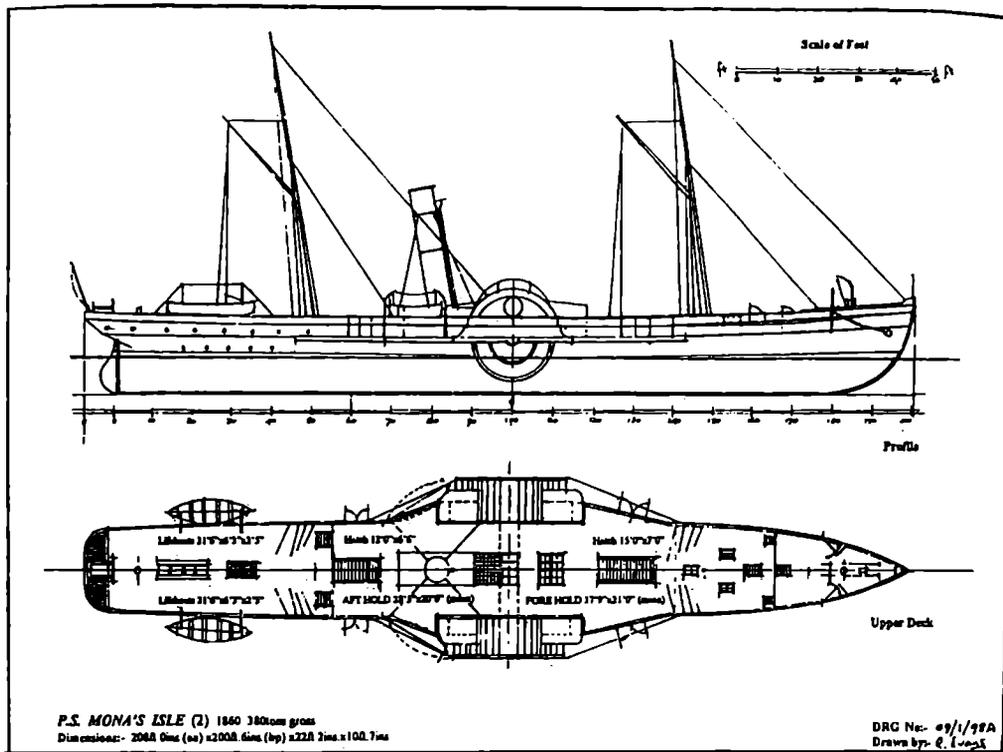
**Fleet List Ref:** 09.

A comparison between the reconstructed drawings (by the author) of the paddle steamer **Mona's Isle** (2) and the twin screw **Ellan Vannin** show many of the modifications which could have resulted in changes to the stability of the vessel, and in the ability of the vessel to resist a large inflow of water and some of these modifications may be summarised as follows:
